**Flood Control Project Maintenance
Levee Inspections**

Fall 2011 Levee Maintenance Deficiency Summary Report

Sacramento River Basin

Sutter Maintenance Yard Hamilton Bend

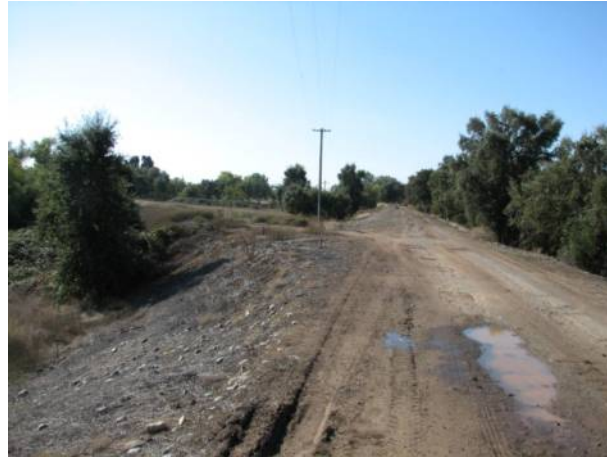
Levee Mile Report Line	1
Start Levee Mile	0.02
End Levee Mile	1.20
Location	Water Side
Category	Earthen Levee
Item	Vegetation

This photo is the landside vegetation at levee mile 1.20 looking downstream.

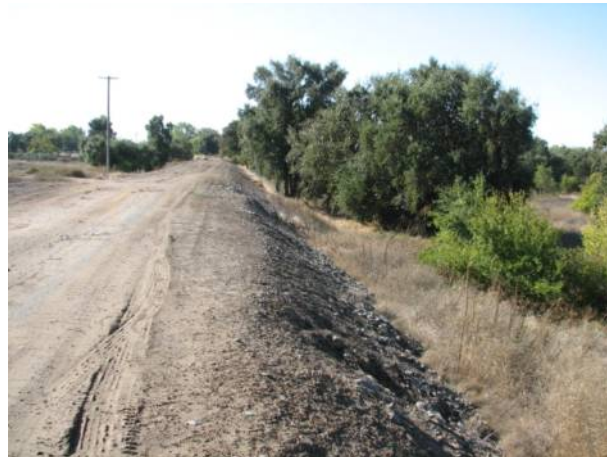
Levee Mile Report Line	2
Start Levee Mile	0.02
End Levee Mile	1.20
Location	Land Side
Category	Earthen Levee
Item	Vegetation

This photo is the landside vegetation at levee mile 1.20 looking downstream.
